HO-1008

Washington Trust Company (Commercial and Farmers Bank, Farmers and Mechanics Bank)
8137 Main Street, Ellicott City

Maryland Inventory of Historic Properties Form

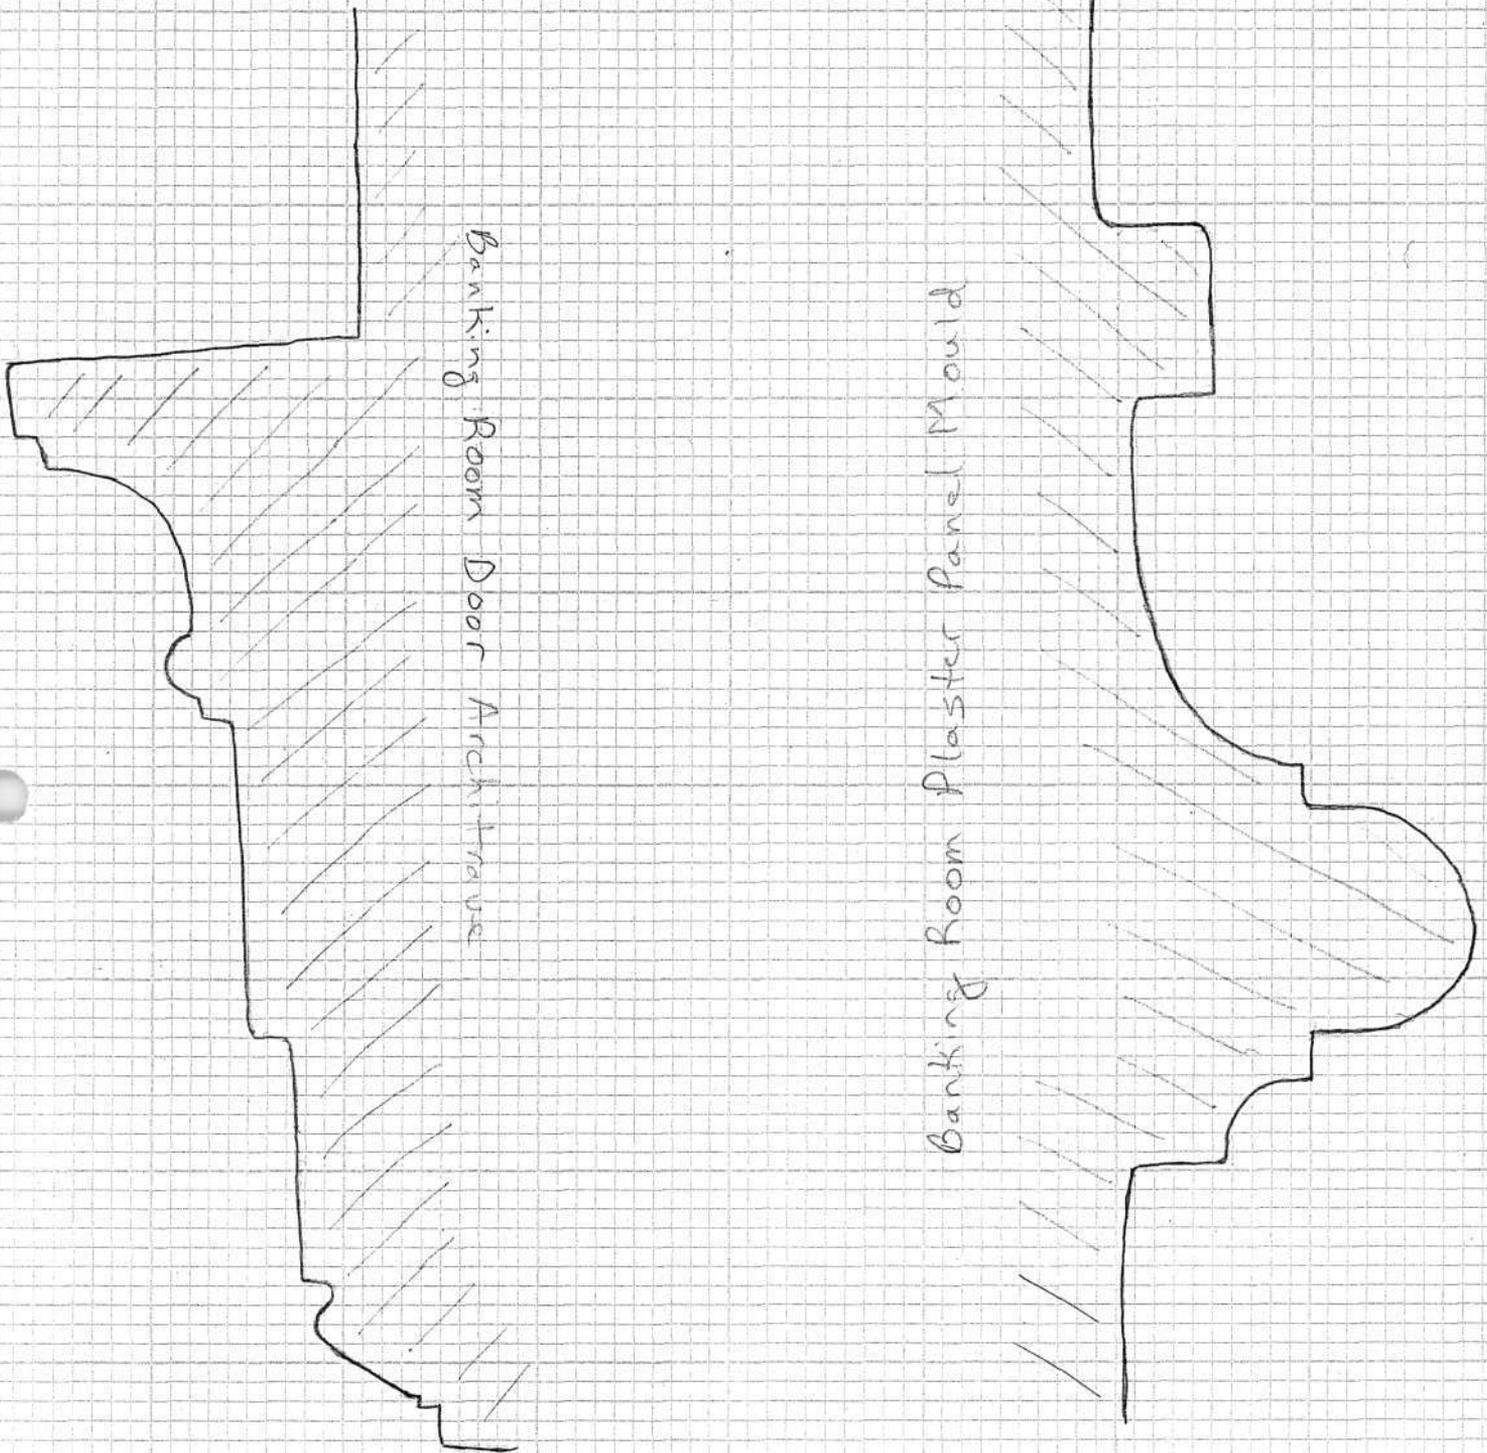
1/4 Washington Trust Co. - 8137 Main St
Moulding Profiles
HO-1008

Banking Room Door Architrave

Banking Room Plaster Panel Mould

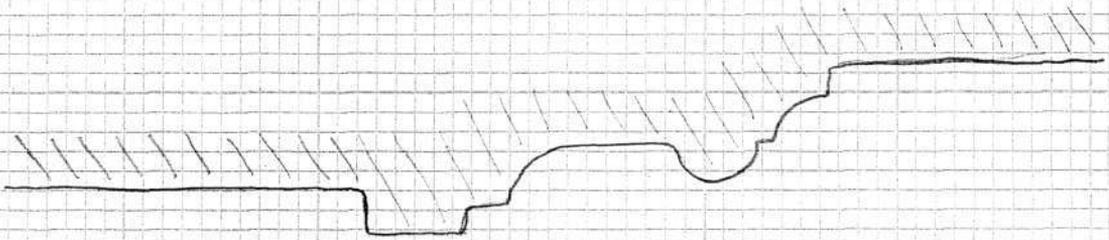
Banking Room Wood Panel Mould

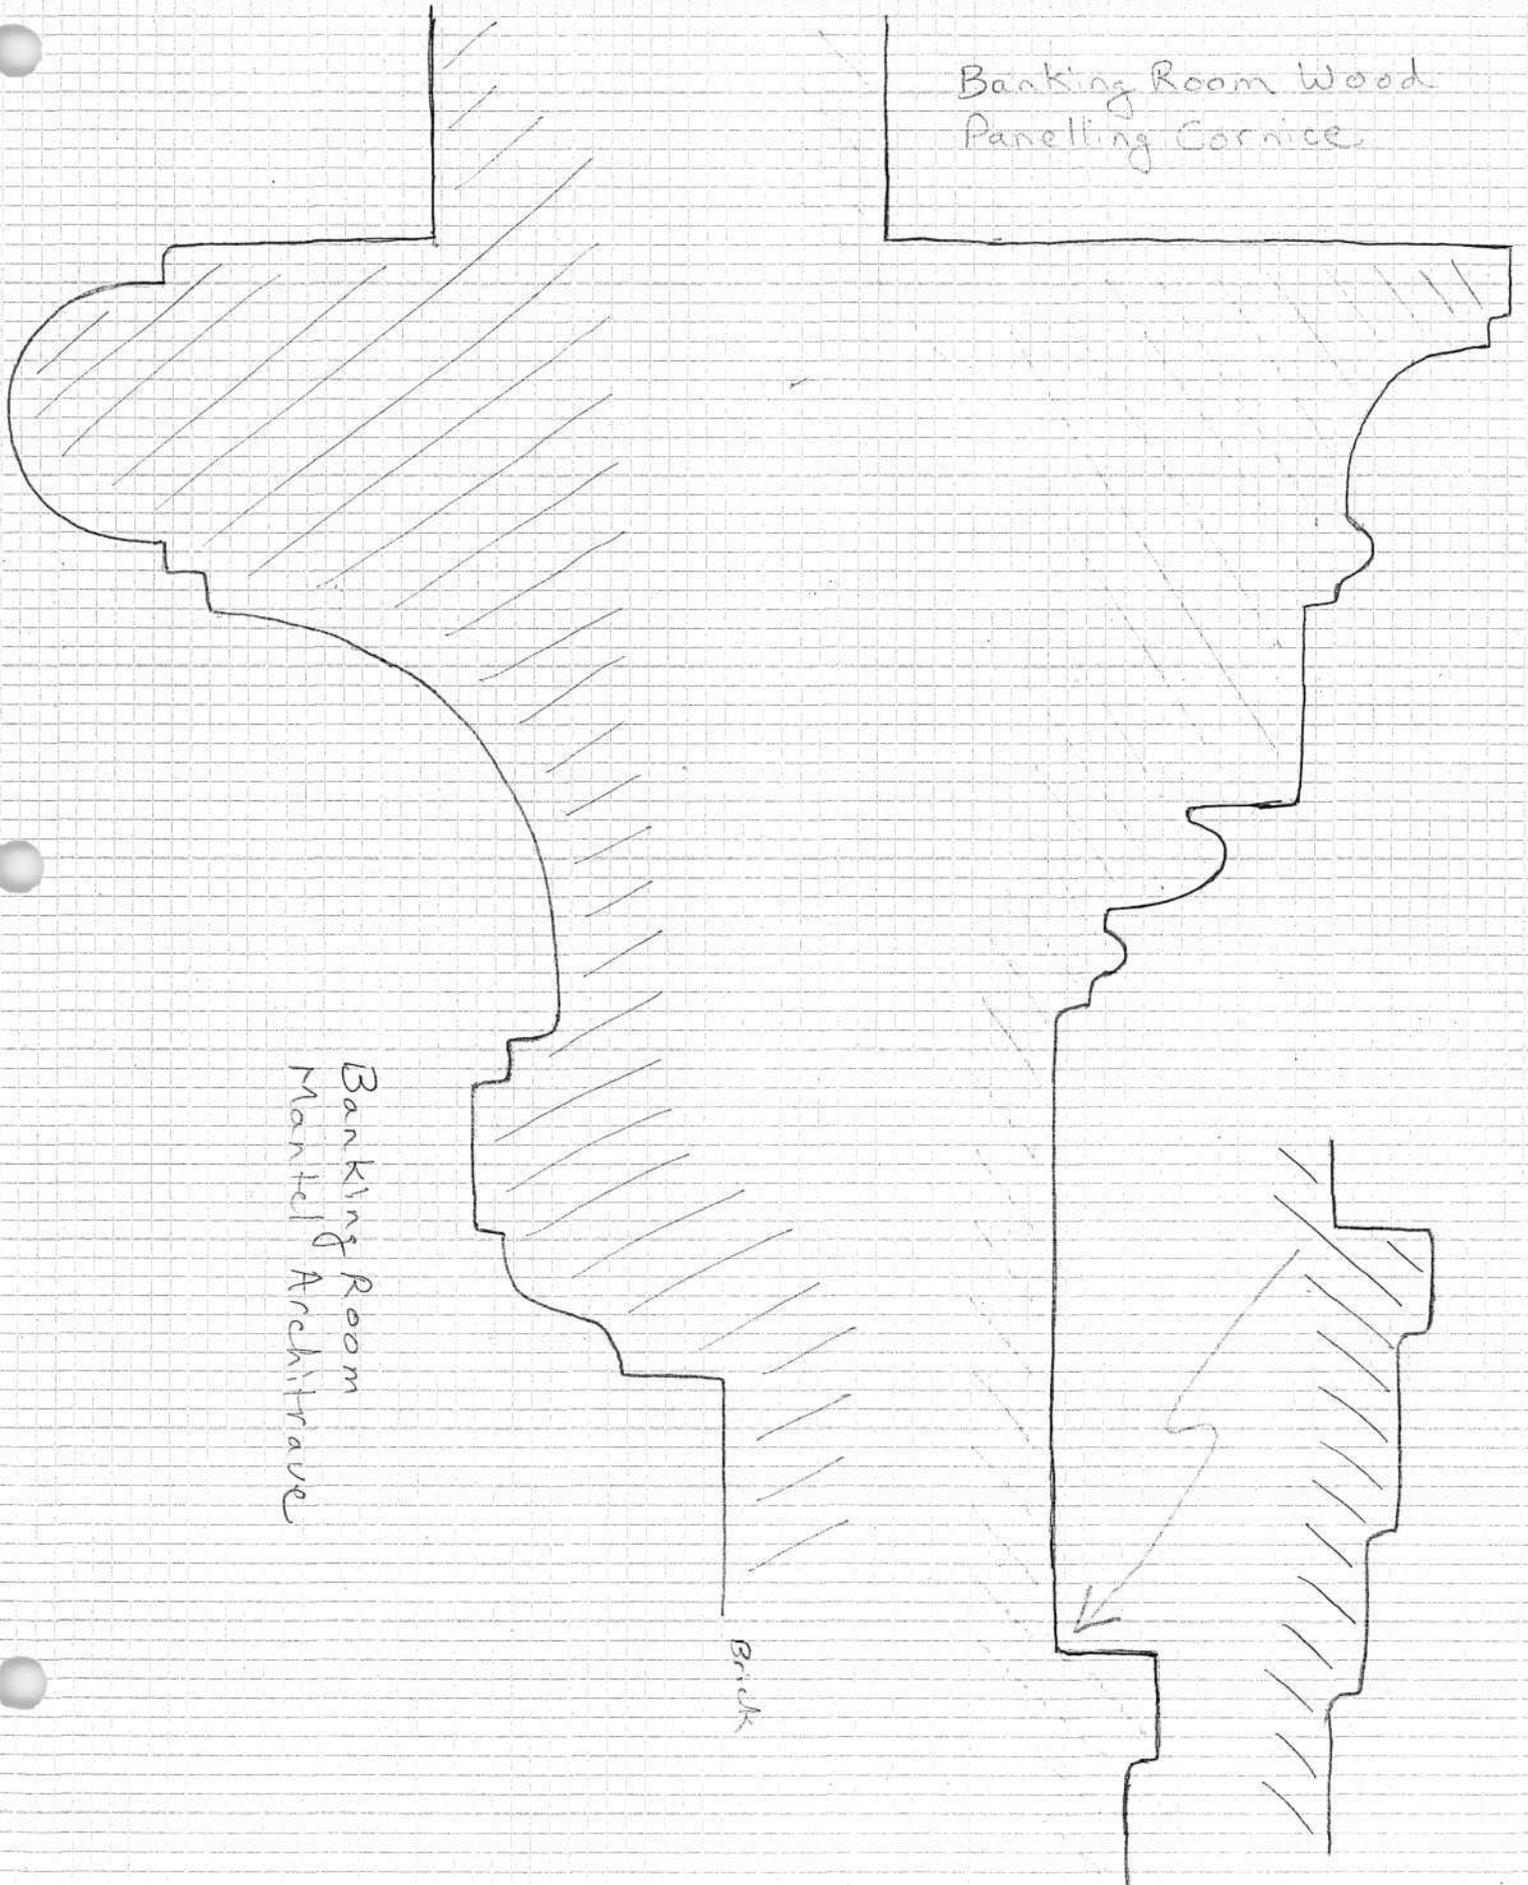
2/4

Banking Room Wood
Panelling Cornice

Banking Room
Mantel Architrave

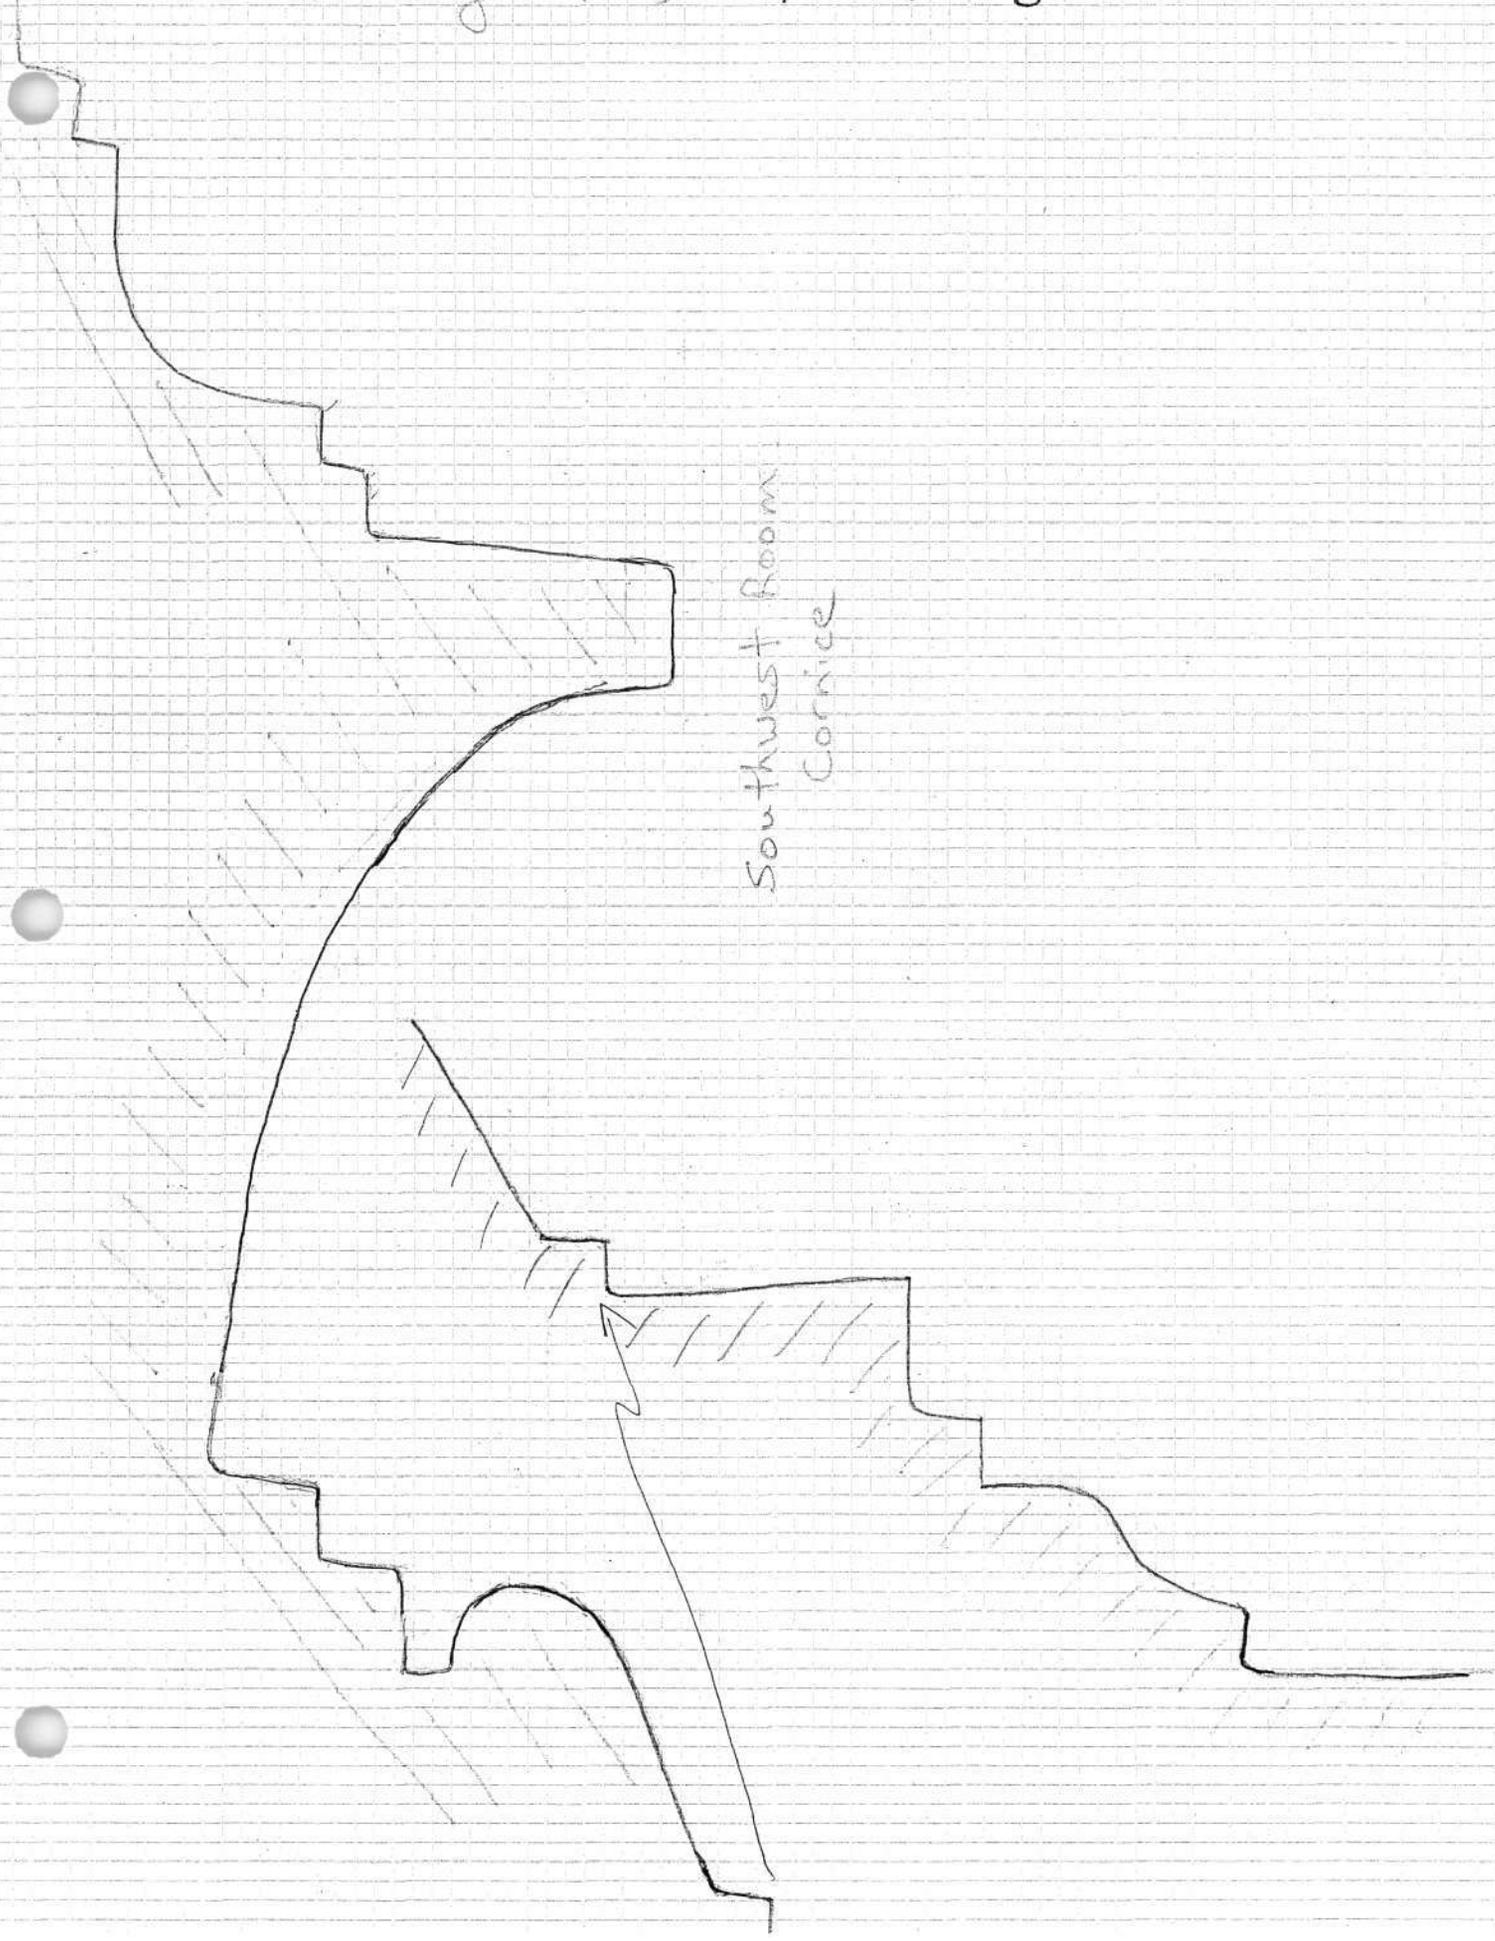
3/4 Washington Trust Co. - 8137 Main St. - Ellicott City KMS
Moulding Profiles HO-1008 16 Apr '02

Southwest Room
Cornice

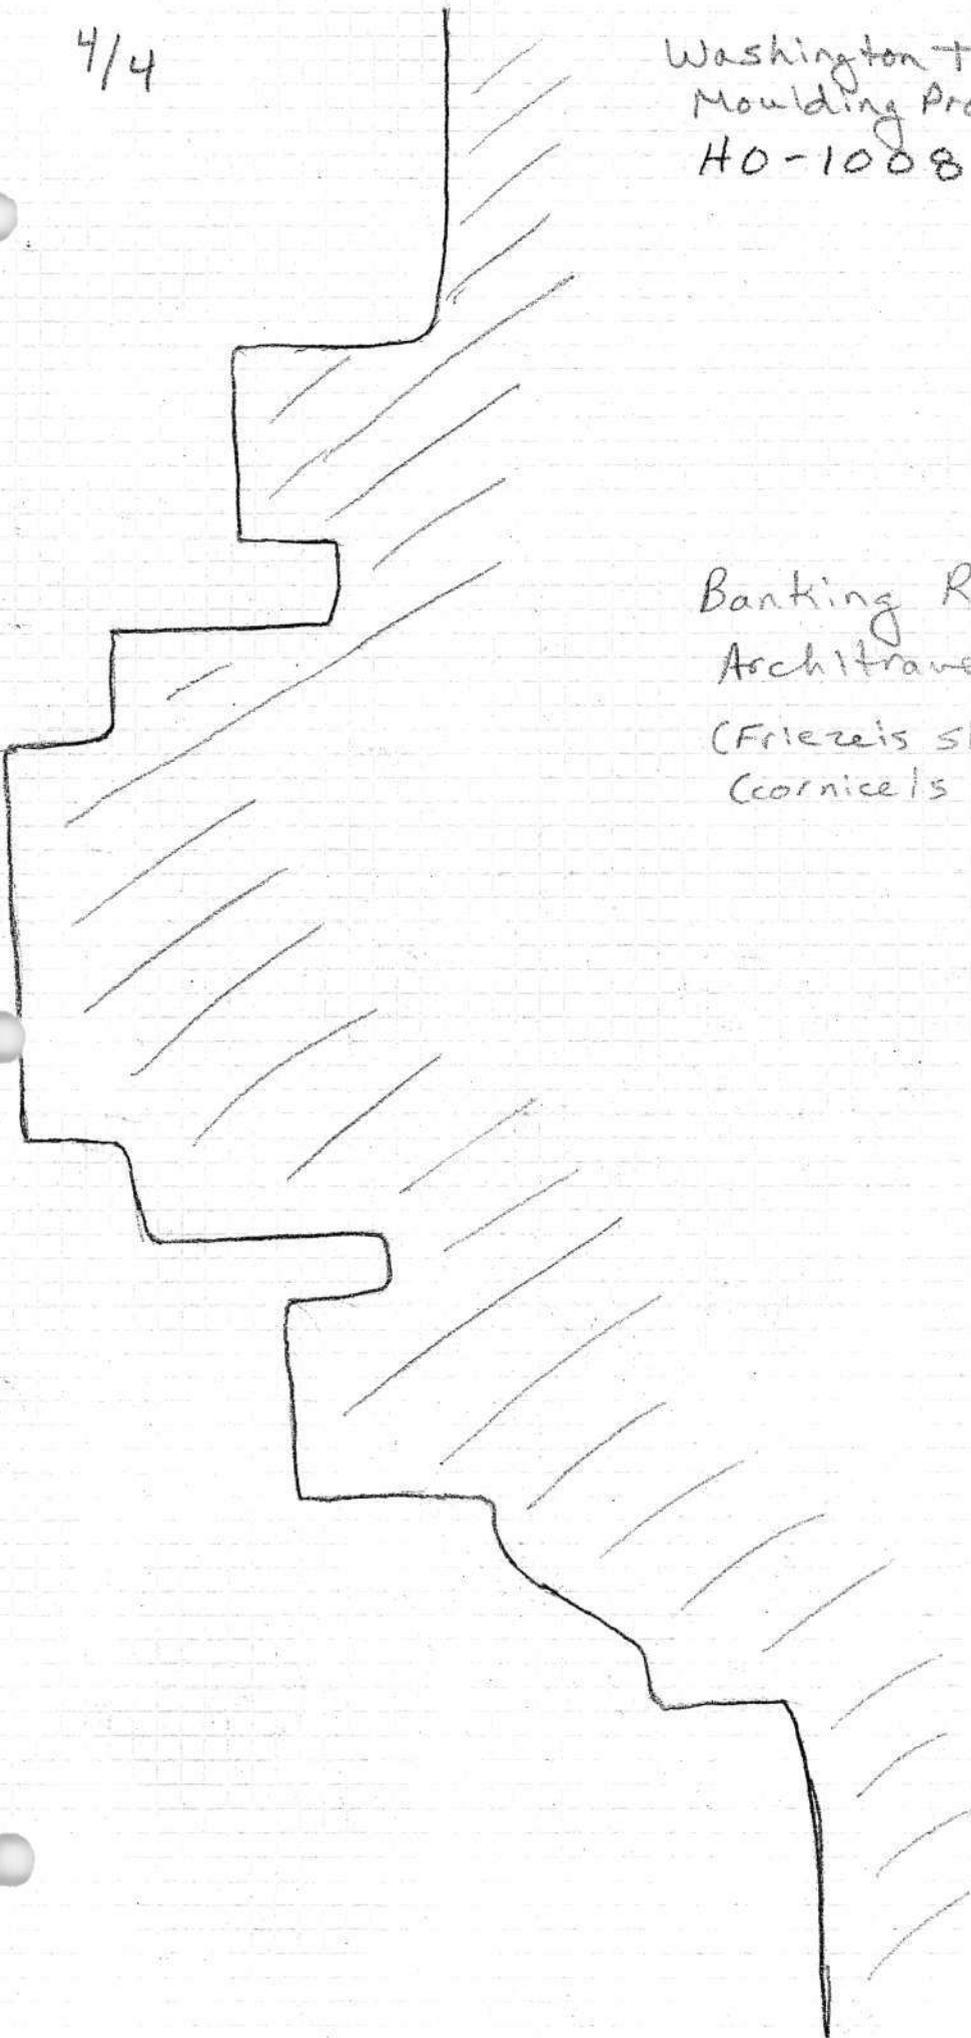
4/4

Banking Room
Architrave
(Frieze is sheetrock)
(cornice is wood)

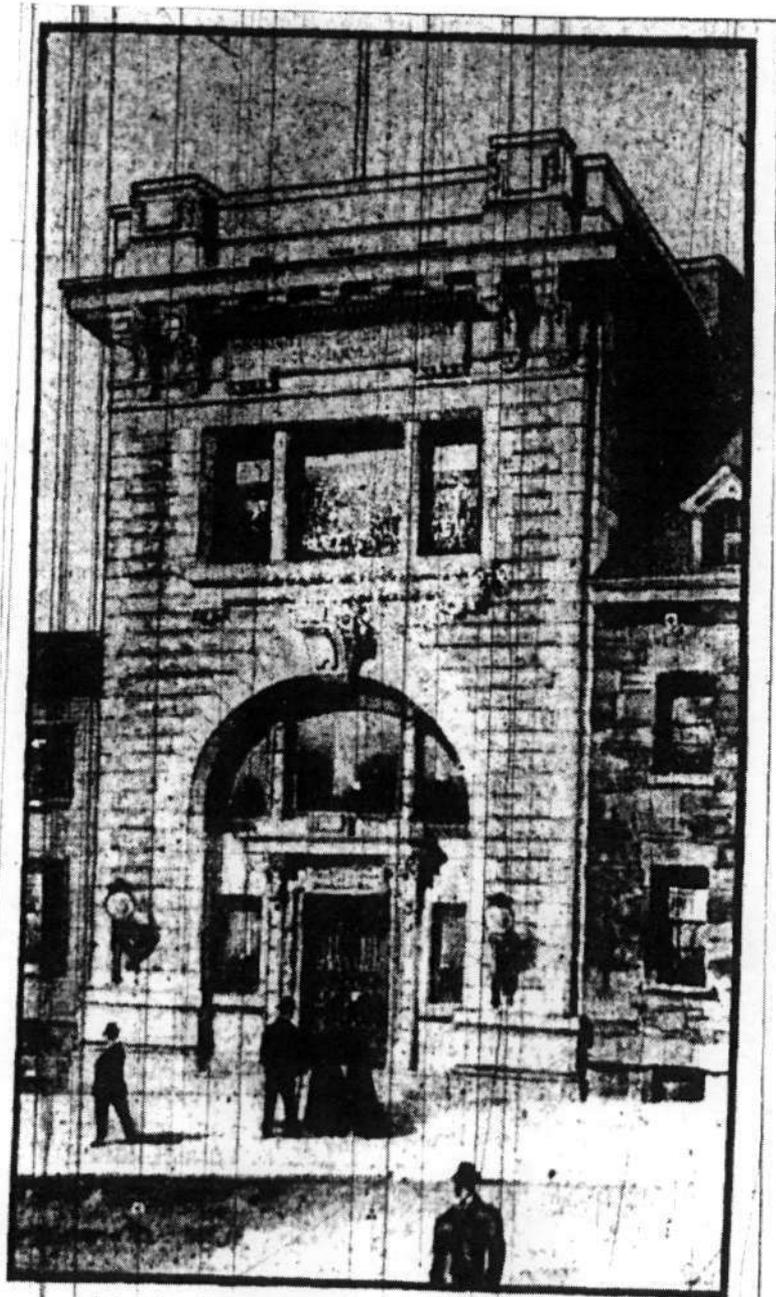
HO-1008
Washington Trust Co.
8137 Main Street, Ellicott City
Historic illustration, *Baltimore*
Sun, 25 April 1906, p. 10

WASHINGTON TRUST COMPANY'S HANDSOME HOME

The architect of the Washington Trust Company building was the Baltimore firm of Mottu and White. Both partners had worked for the Baltimore firm of Baldwin & Pennington and formed their own firm in 1904, so this was an early work in a career that would varied building types throughout Maryland. Perhaps their most famous design was the Art Deco Baltimore Life Insurance Company Building of 1930 on Charles Street in downtown Baltimore. The *Baltimore Sun* noted before construction began: "The front is to be of Beaver Dam marble [from Baltimore County], with a granite base and steps and terra cotta cornice." A promotional advertisement published before its completion added: "It . . . will be entered through an imposing marble arch nineteen feet high." The interior arrangement was described in detail, based on the plans:

The first floor, which will be 21 feet high, will be arranged with working space in the middle of the building, with public space around the three sides, the public space affording access to a large committee room at the southwest corner of the building and to the coupon and ladies' room at the southeast corner. Facing the entrance and in the rear of the working space will be a . . . vault. . . . In the rear of the vault are two toilets, one for ladies, opening in the ladies' room, and the other for the officers of the trust company. The banking room will be wainscoted with a quartered-oak paneled wainscoting, while the public space floor will be of white Vermont marble. A stairway will be approached from the public space on the west side of the building which will lead to the mezzanine, or gallery floor, which will be over the vault, committee room, ladies' room, passage behind vault, toilets, etc. This stairway will continue to the second floor, where will be the directors' room. The directors' room will cover the entire floor and will be lighted, as in the banking room, from both front and rear of the building.

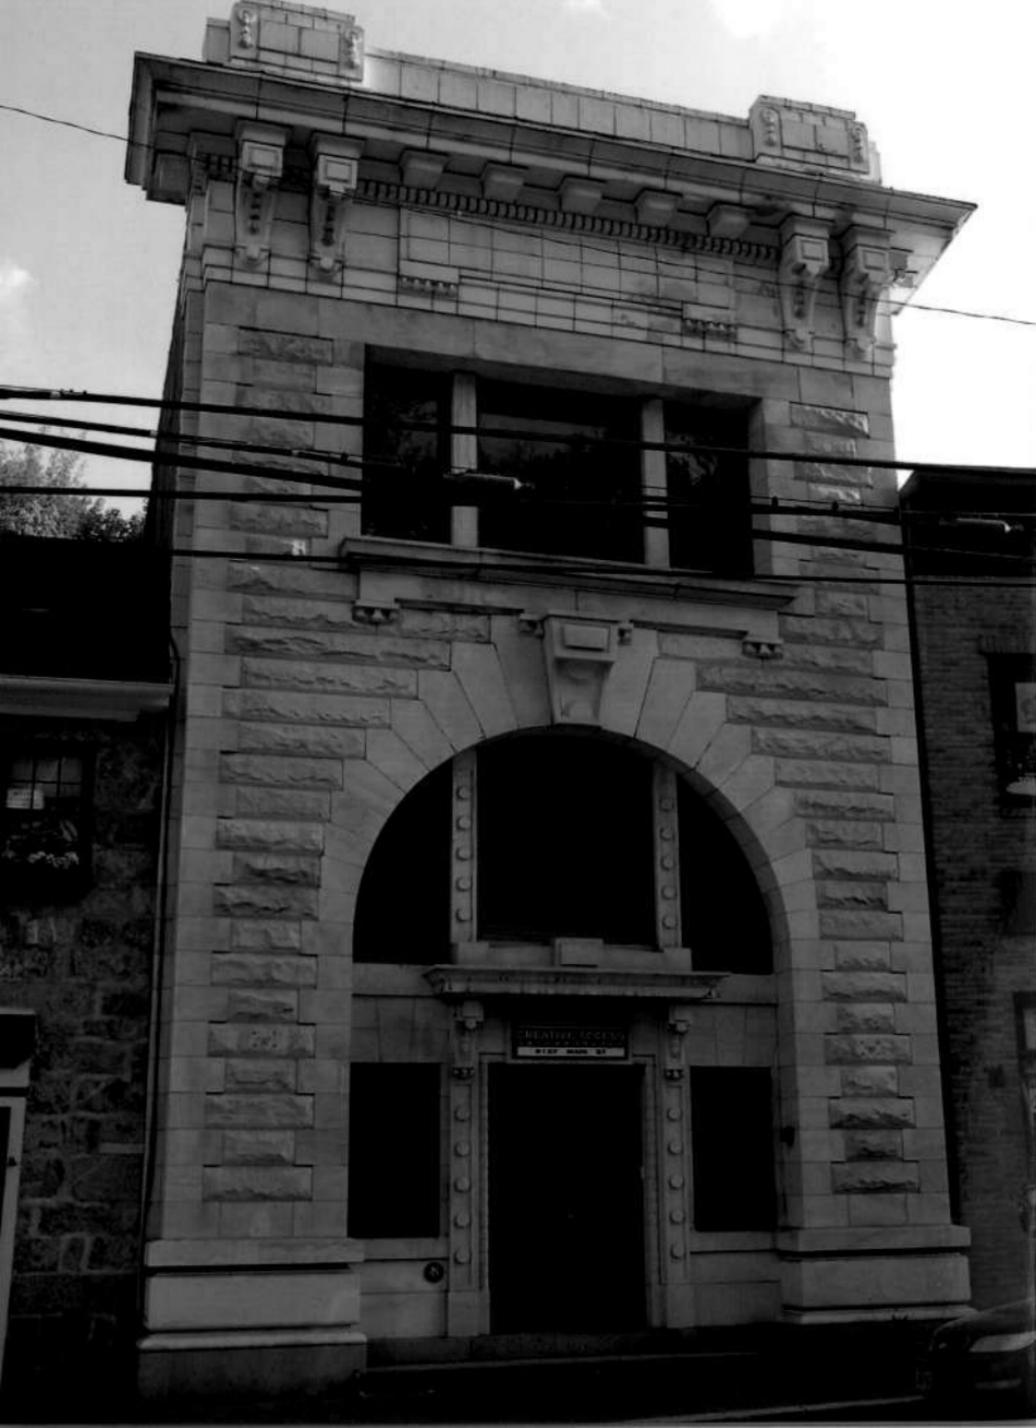
1/2

North Elevation

The Farmers and Mechanics Bank is a two-story, one-bay structure that faces north toward Main Street, and has brick party walls on the east and west. The north elevation has rock-faced marble ashlar with smooth ashlar quoins, and a terra cotta frieze, cornice and parapet. The first story has a large semicircular arch with central paired iron doors. Flanking the doors inside the arch is an original window with iron grille to the east and a new iron grille that replaced a modern bank night drop vault in the window opening to the west. Above the doors and windows is a Diocletian window with a bracket keystone. The second story has a tripartite window. There is a flat, built-up roof behind the parapet. The south elevation, which is brick, abuts Tiber Run, and there is no access to it.

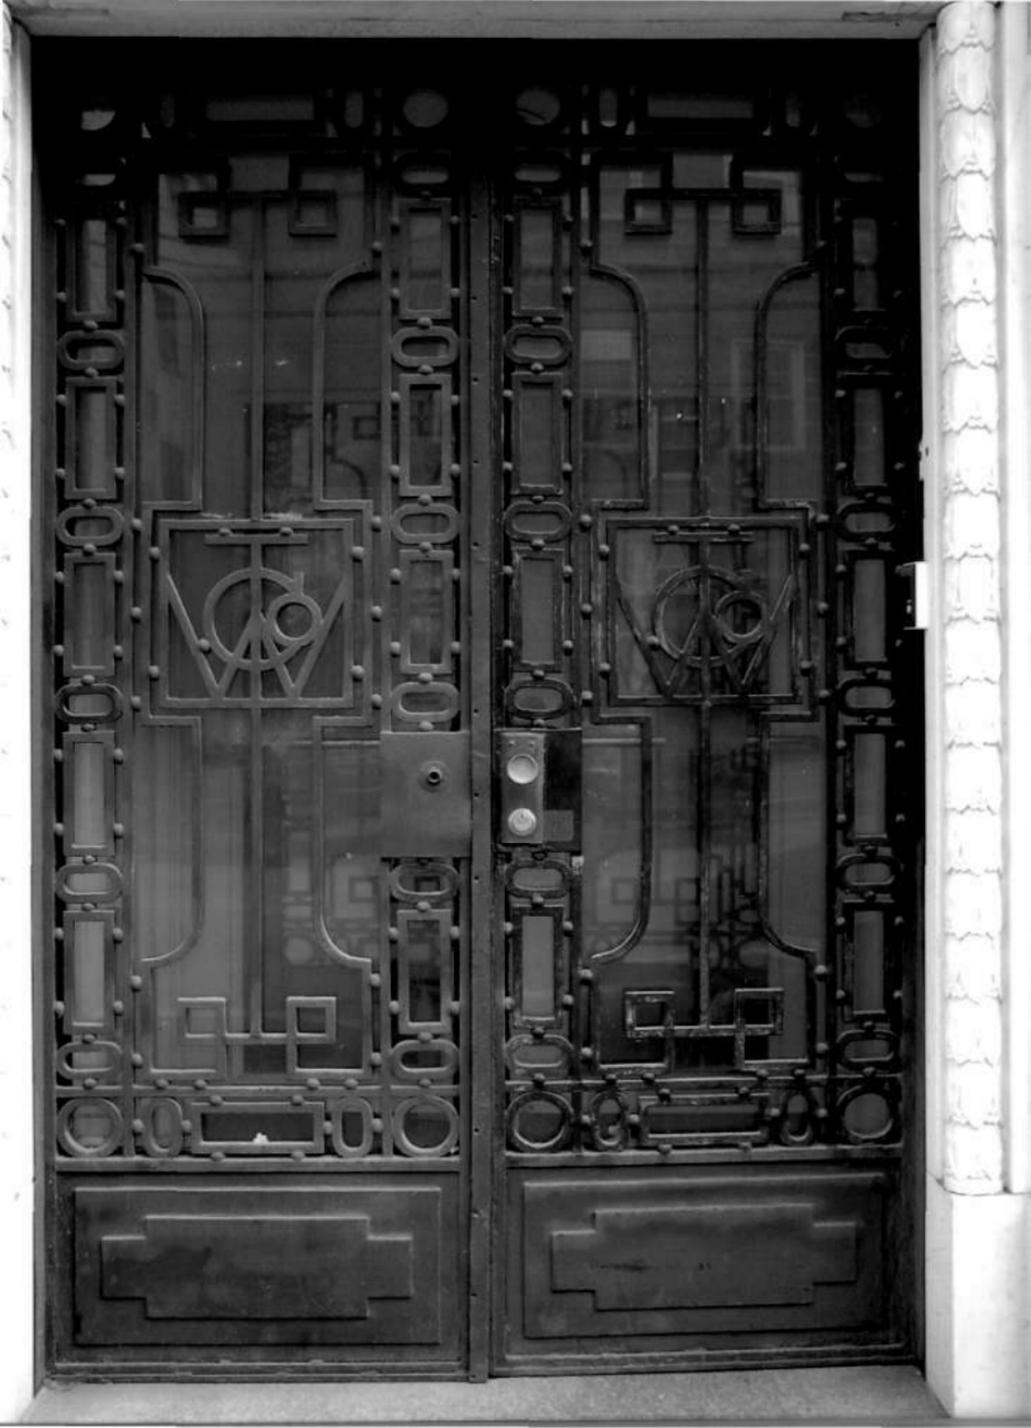
2/2

North: Elevation, Door
